# **UVDECHLO**CD600 ECOENERGY

Flow rate: from 300 to 450 m<sup>3</sup>/h

**REF**: 19000114

The **UVDECHLO CD600** reduces the level of combined chlorine in swimming pools through a photochemical action on all organochlorine compounds found in the water (monochloramine, dichloramine trichloramine). It also destroys Giardia and Cryptosporidum.

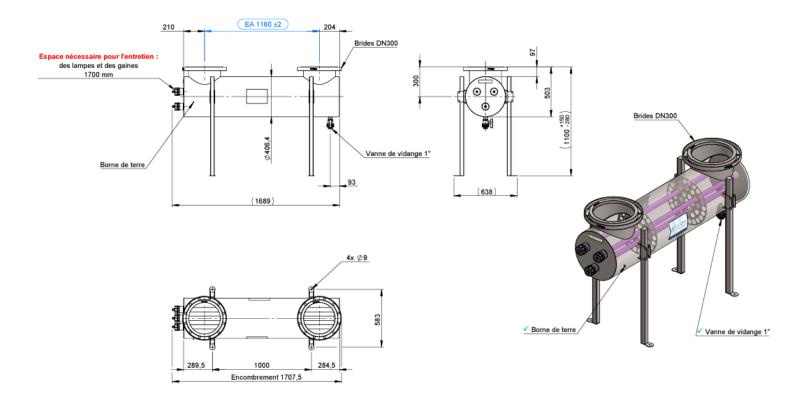
# INSTALLATION

The dechloramination unit must be installed horizontally: water flow can be in either direction, but we recommend that the water flows in from the top and out from the top of the unit to avoid any accumulation of air in the treatment chamber and to ensure that it always remains full of water. Sufficient clearance must be provided along the dechloramination unit (1.70 m) to allow for maintenance and UV lamp replacement.

Filtration is required to remove suspended solids. The dechloramination unit is therefore installed after the pool filters, but before chlorine injection as the chlorine molecules can be degraded by UV radiation.
